BEARING FAILURE: CAUSES AND CURES

Identifying and correcting causes of bearing failure.

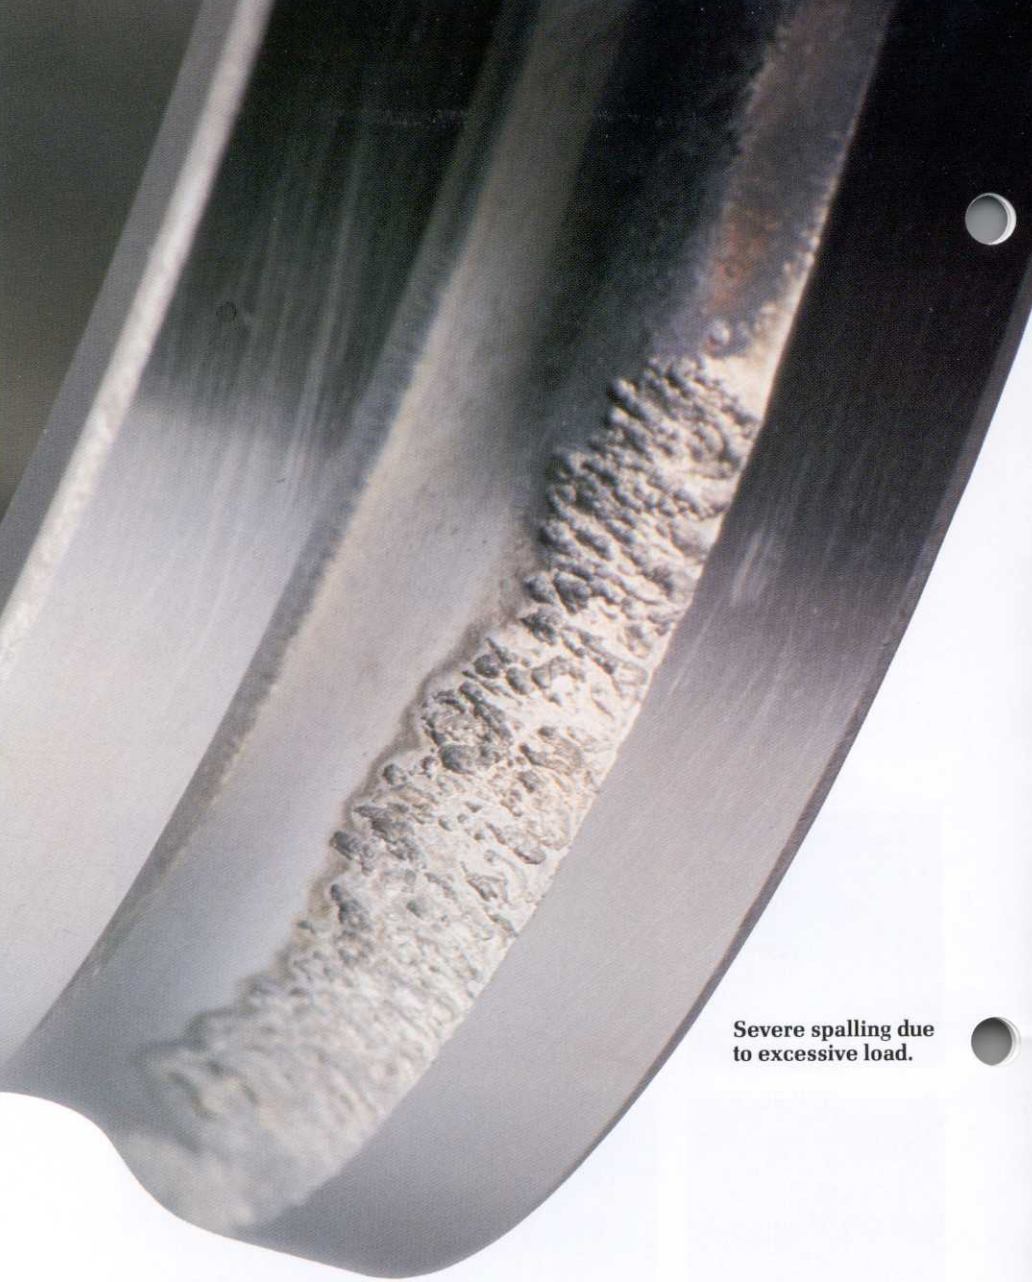
EXCESSIVE LOADS

Severe spalling due to excessive load.

Excessive loads usually cause premature fatigue. Tight fits, brinelling and improper preloading can also bring about early fatigue failure, (see Tight Fits, p. 15 and True Brinelling, p. 7). This type of failure looks the same as normal fatigue, although heavy ball wear paths, evidence of overheating and a more widespread spalling (fatigue area) are usually evident with shortened life.

The solution is to reduce the load or redesign using a bearing with greater capacity.

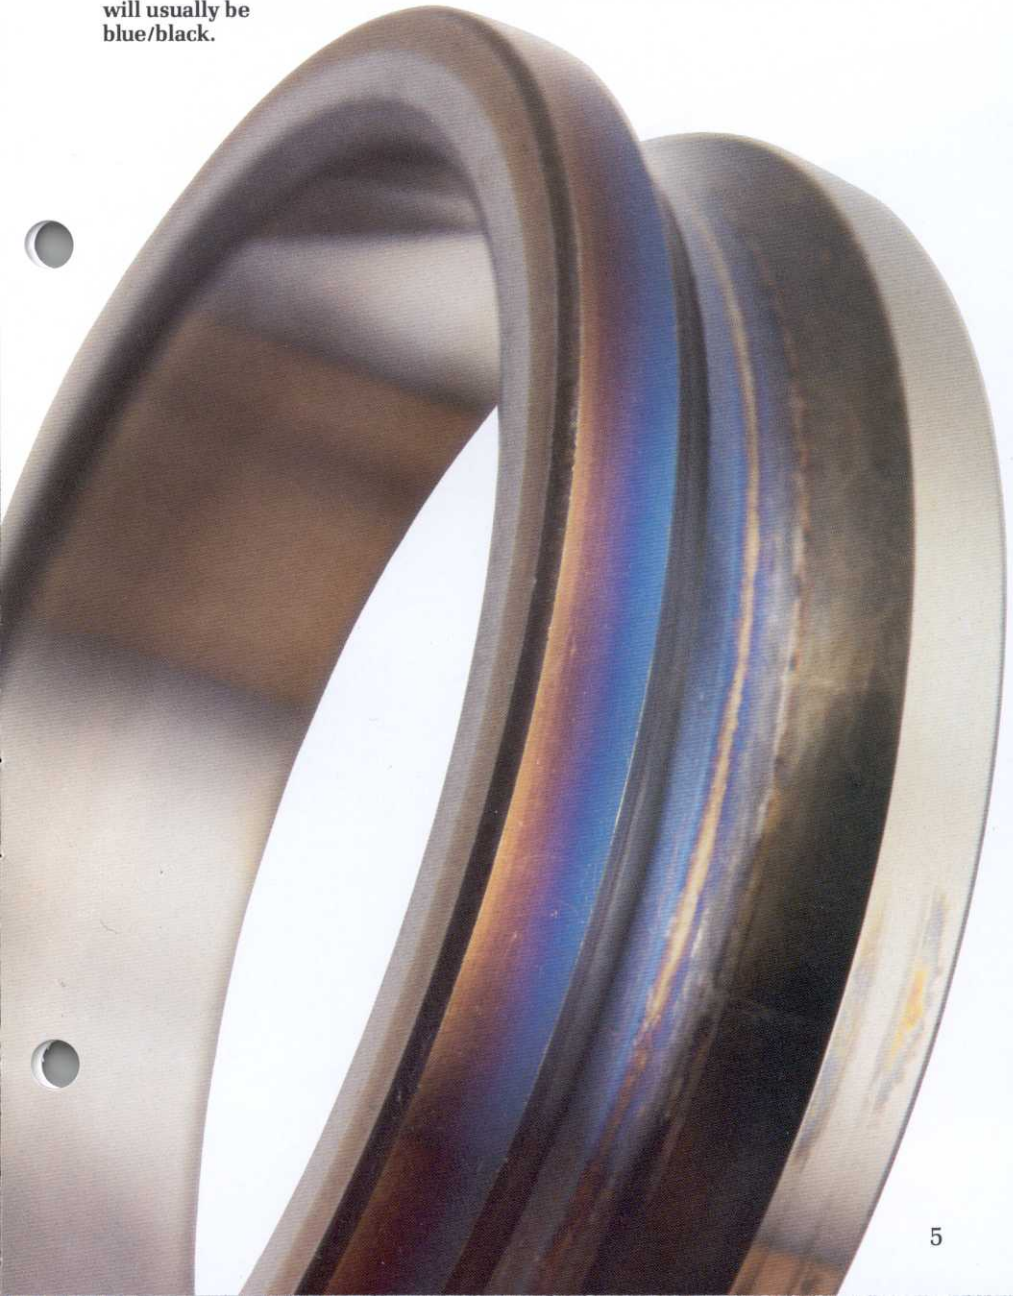
OVERHEATING

Symptoms are discoloration of the rings, balls, and cages from gold to blue. Temperatures in excess of 400°F can anneal the ring and ball materials. The resulting loss in hardness reduces the bearing capacity causing early failure. In extreme cases, balls and rings will deform. The temperature rise can also degrade or destroy lubricant.

Common culprits are heavy electrical heat loads, inadequate heat paths, and insufficient cooling or lubrication when loads and speeds are excessive. Thermal or overload controls, adequate heat paths, and supplemental cooling are effective cures.

Look for blue/black and silver/gold discoloration. Balls will usually be blue/black.

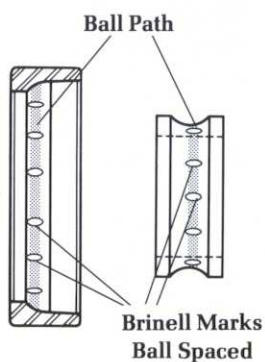
FALSE BRINELLING

False brinelling—elliptical wear marks in an axial direction at each ball position with a bright finish and sharp demarcation, often surrounded by a ring of brown debris—indicates excessive external vibration. A small relative motion between balls and raceway occurs in non-rotating ball bearings that are subject to external vibration. When the bearing isn't turning, an oil film cannot be formed to prevent raceway wear. Wear debris oxidizes and accelerates the wear process.

False brinell marks are bright, well-defined, and surrounded by debris.

Correct by isolating bearings from external vibration, and using greases containing antiwear additives such as molybdenum disulfide when bearings only oscillate or reverse rapidly as in actuator motors.

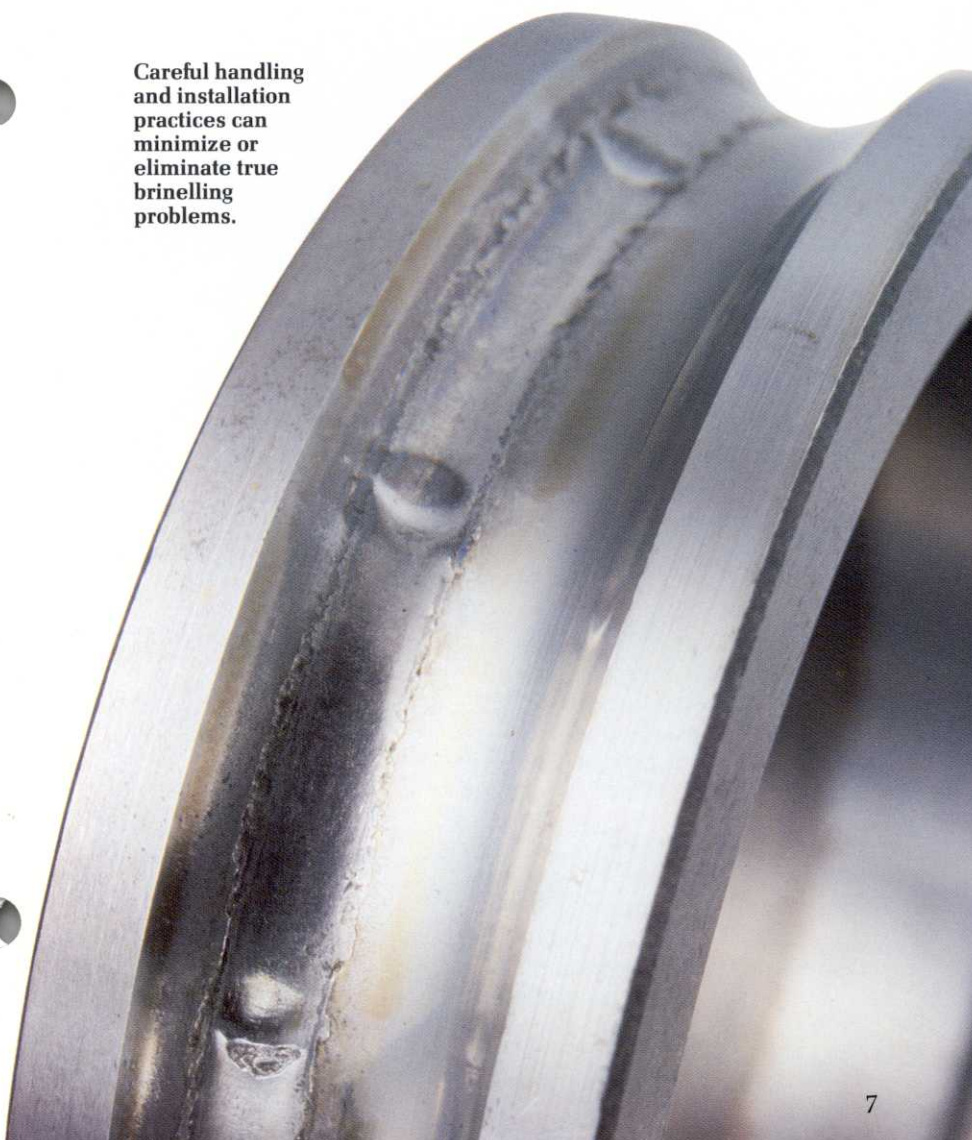
TRUE BRINELLING

Brinelling occurs when loads exceed the elastic limit of the ring material. Brinell marks show as indentations in the raceways which increase bearing vibration (noise). Severe brinell marks can cause premature fatigue failure.

Any static overload or severe impact can cause brinelling. Examples include: using hammers to remove or install bearings, dropping or striking assembled equipment, and pressing a bearing onto a shaft by applying force to the outer ring.

Install bearings by applying force only to the ring being press-fitted, i.e., do not push the outer ring to force the inner ring onto a shaft.

Careful handling and installation practices can minimize or eliminate true brinelling problems.

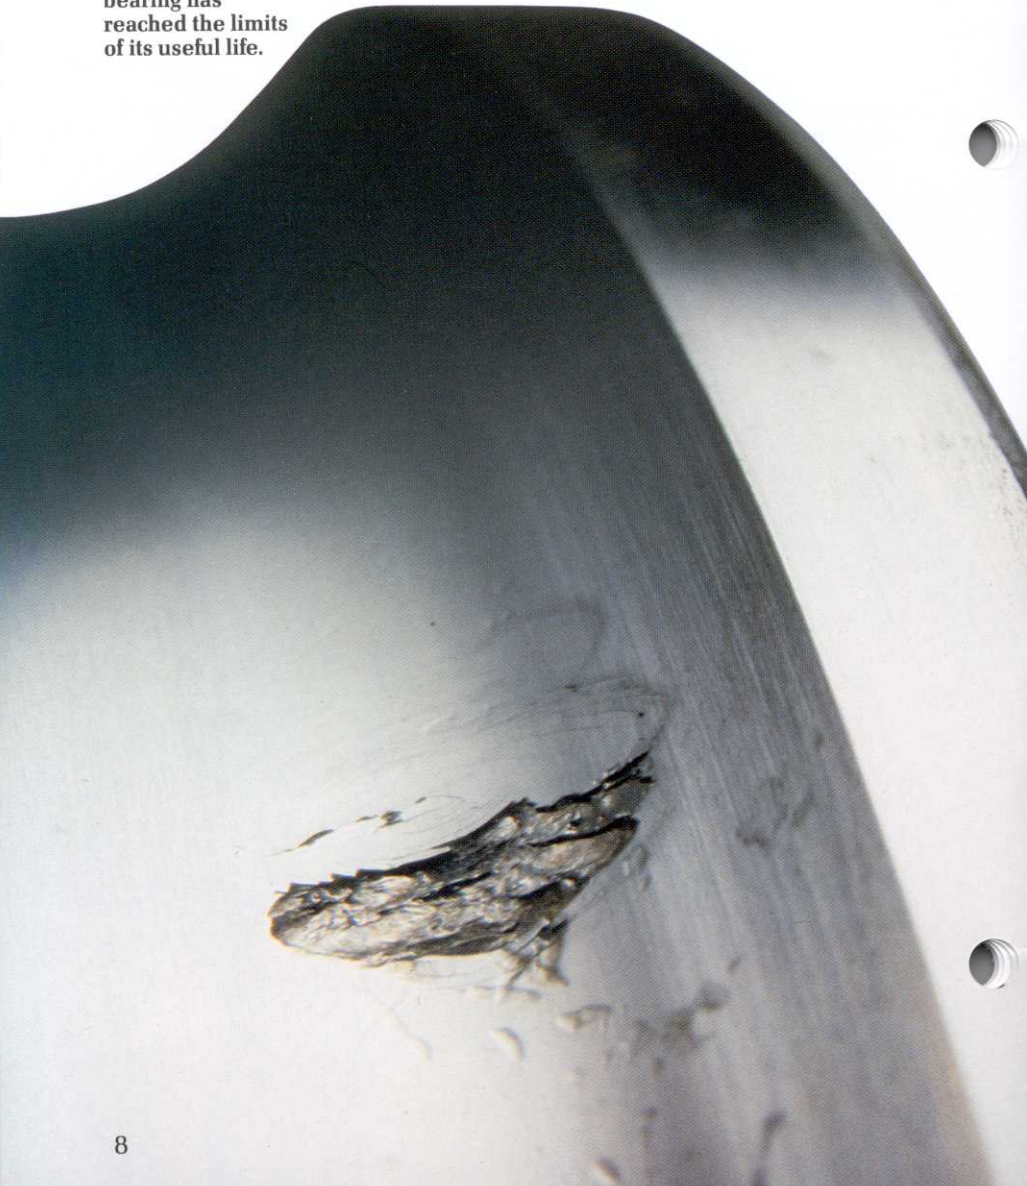
NORMAL FATIGUE FAILURE

Fatigue failure—usually referred to as spalling—is the fracture of the running surfaces and subsequent removal of small, discrete particles of material.

Spalling can occur on the inner ring, outer ring, or balls. This type of failure is progressive and once initiated will spread as a result of further operation. It will always be accompanied by a marked increase in vibration, indicating an abnormality.

Moderately spalled area indicates bearing has reached the limits of its useful life.

The remedy is to replace the bearing or consider redesigning to use a bearing having a greater calculated fatigue life.

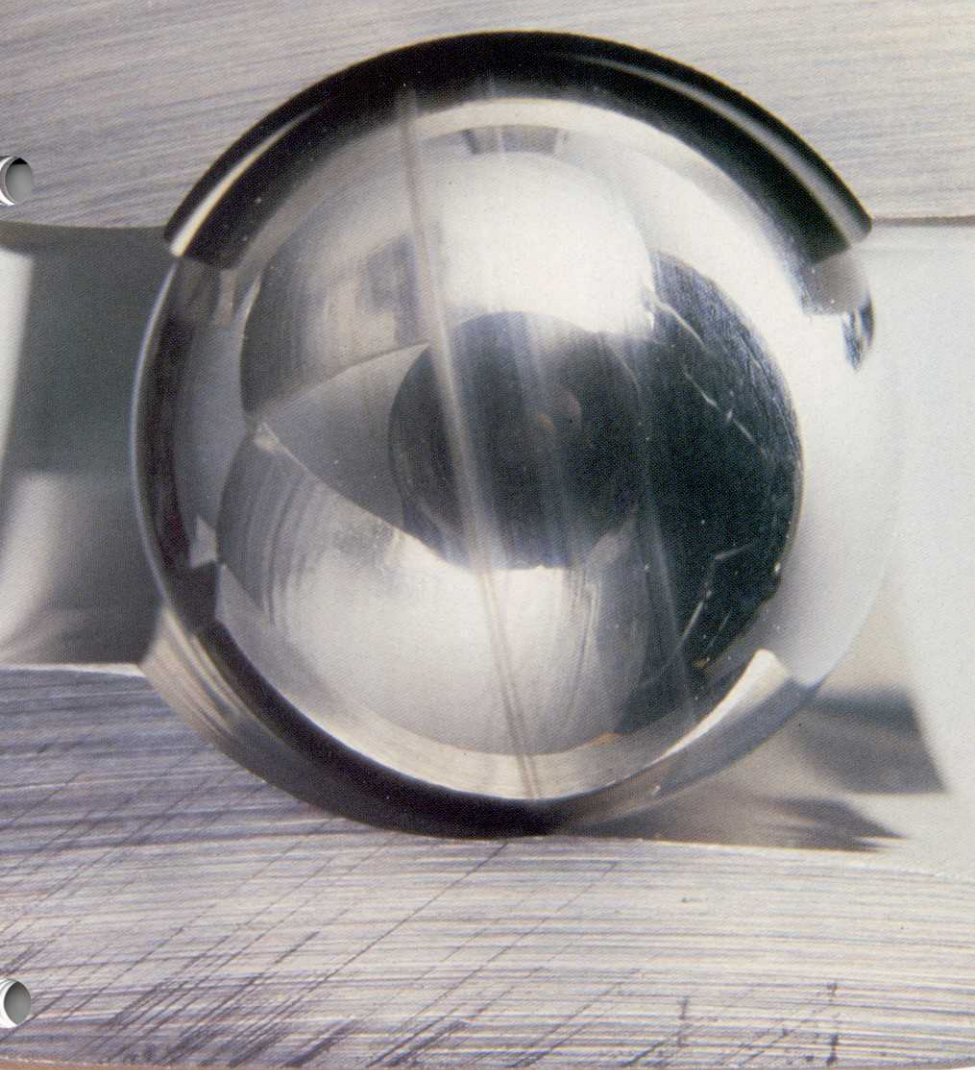
REVERSE LOADING

Thrust load applied to wrong faces results in wear band on balls.

Angular contact bearings are designed to accept an axial load in one direction only. When loaded in the opposite direction, the elliptical contact area on the outer ring is truncated by the low shoulder on that side of the outer ring. The result is excessive stress and an increase in temperature, followed by increased vibration and early failure.

Failure mode is very similar to that of heavy interference (tight) fits. The balls will show a grooved wear band caused by the ball riding over the outer edge of the raceway.

Ball band caused by ball riding over edge of raceway.

Corrective action is to simply install the bearing correctly. Angular contact bearings must be installed with the resultant thrust on the wide face—which is marked “thrust”—of the outer ring and the opposite face of the inner ring.

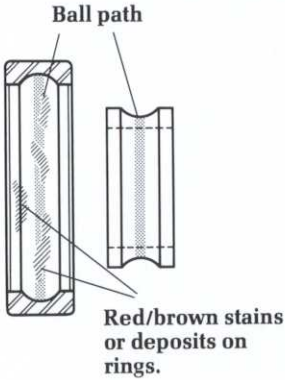
CORROSION

Red/brown areas on balls, raceways, cages, or bands of ball bearings are symptoms of corrosion. This condition results from exposing bearings to corrosive fluids or a corrosive atmosphere. The usual result is increased vibration followed by wear, with subsequent increase in radial clearance or loss of preload. In extreme early cases, corrosion can initiate early fatigue failures.

Corrosion results from the chemical attack on the metal by hostile fluids or atmospheres.

Correct by diverting corrosive fluids away from bearing areas and use integrally sealed bearings whenever possible. If the environment is particularly hostile, the use of external seals in addition to integral seals should be considered. The use of stainless steel bearings is also helpful.

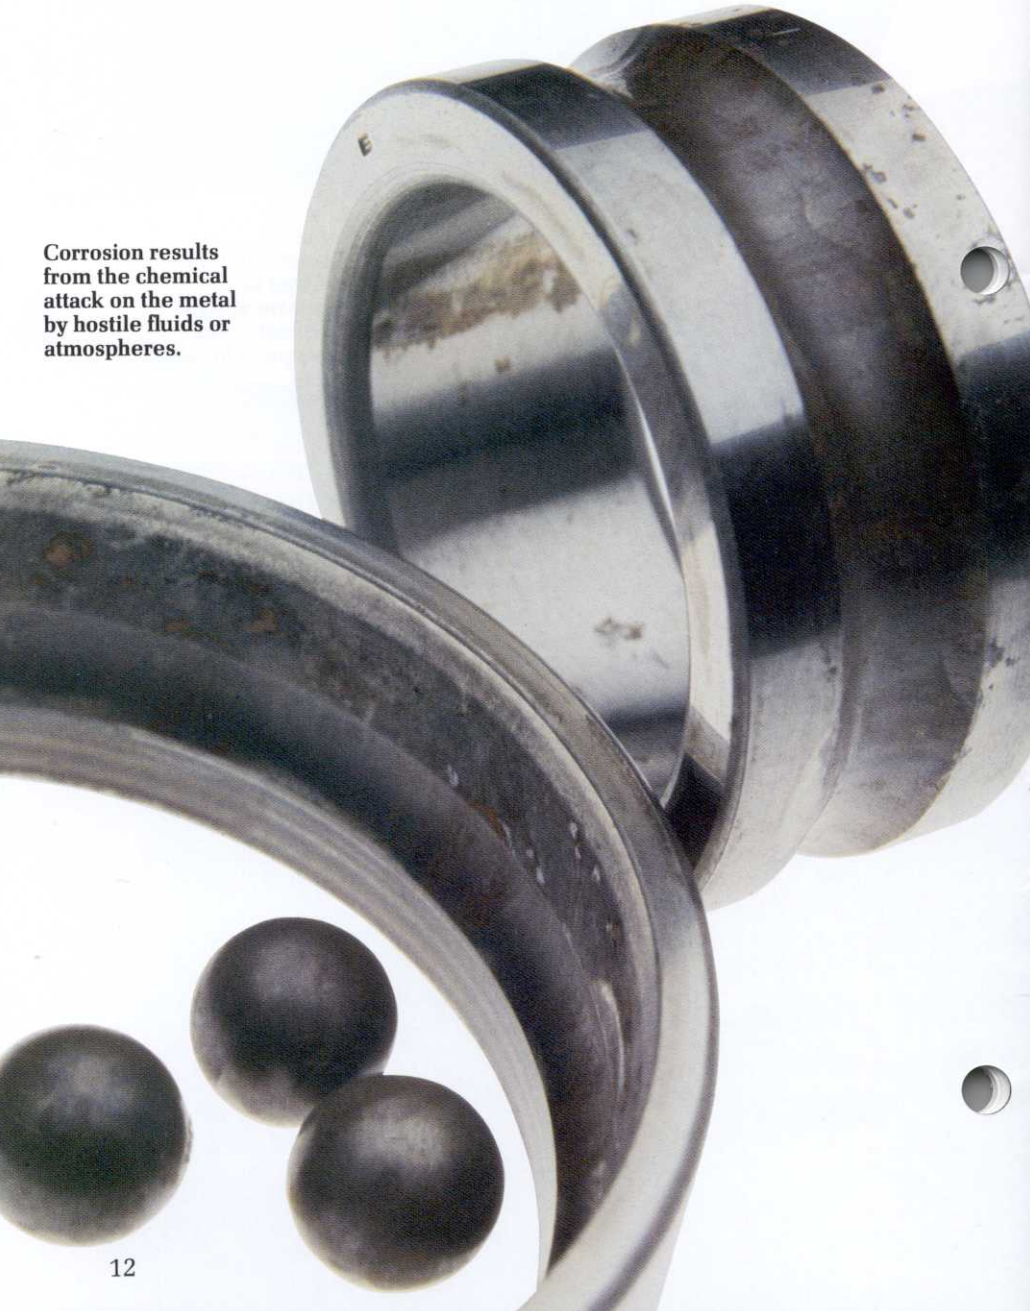
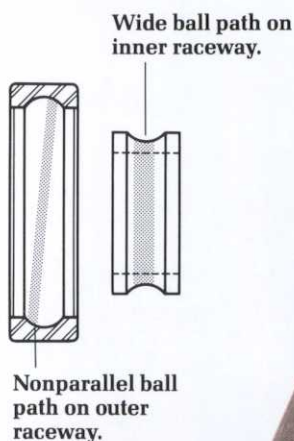
MISALIGNMENT

Misalignment can be detected on the raceway of the nonrotating ring by a ball wear path that is not parallel to the raceway edges. If misalignment exceeds 0.001 in./in you can expect an abnormal temperature rise in the bearing and/or housing and heavy wear in the cage ball-pockets.

The most prevalent causes of misalignment are: bent shafts, burrs or dirt on shaft or housing shoulders, shaft threads that are not square with shaft seats, and locking nuts with faces that are not square to the thread axis. The maximum allowable misalignment varies greatly with different applications, decreasing, for example, with speed.

Abnormal temperature rises and premature wear of cage results from misalignment.

Appropriate corrective action includes: inspecting shafts and housings for runout of shoulders and bearing seats; use of single point-turned or ground threads on nonhardened shafts and ground threads only on hardened shafts; and using precision grade locknuts.

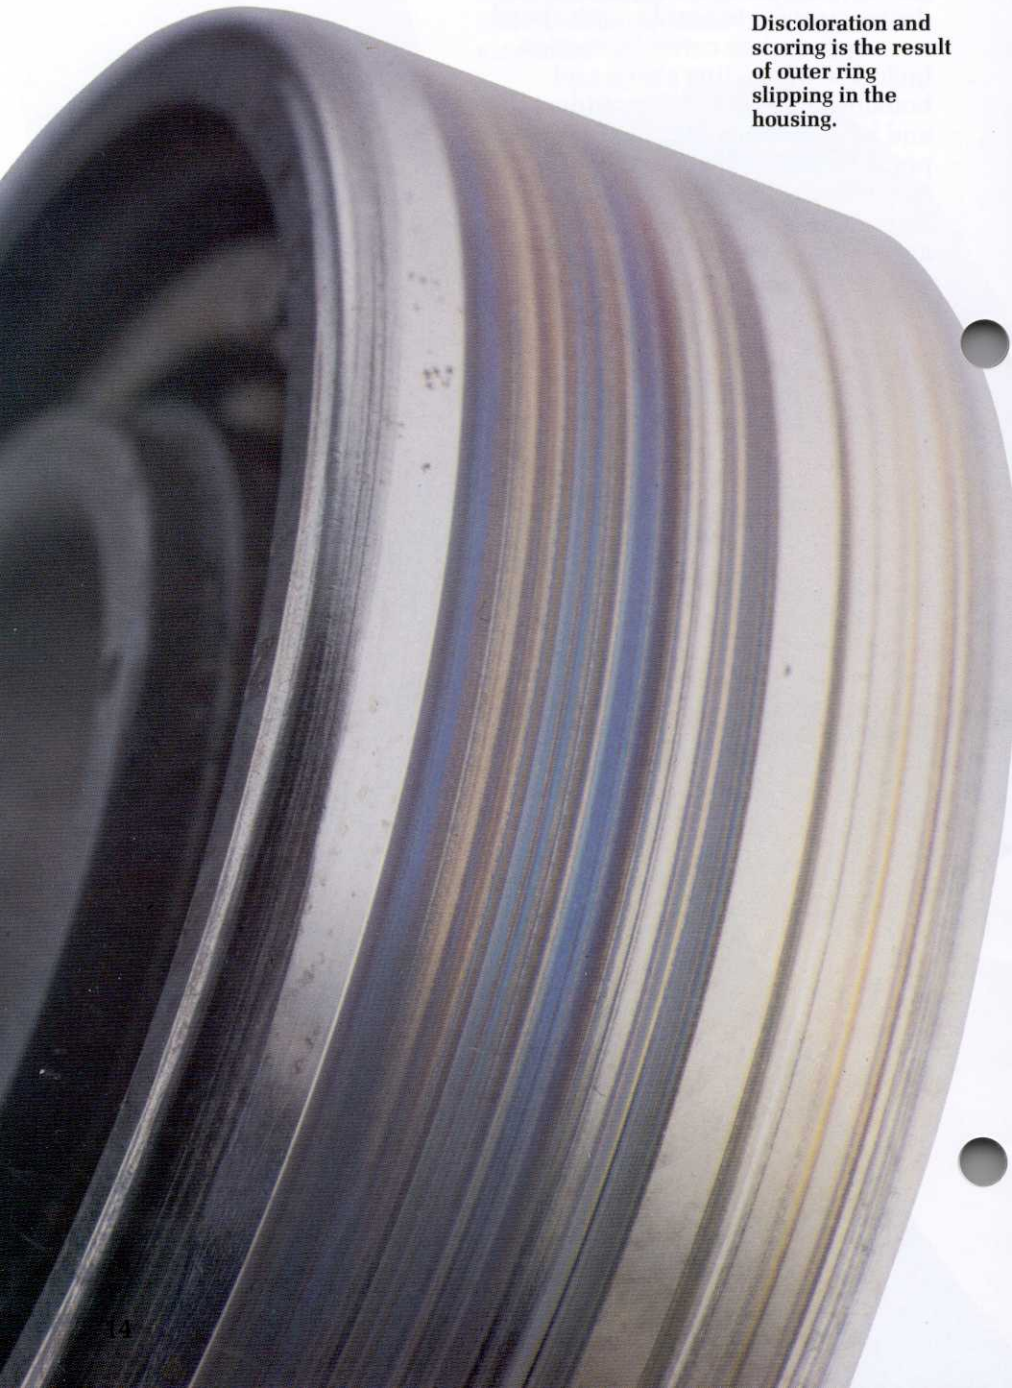
LOOSE FITS

Outer ring slippage caused by improper housing fits.

Loose fits can cause relative motion between mating parts. If the relative motion between mating parts is slight but continuous, fretting occurs.

Fretting is the generation of fine metal particles which oxidize, leaving a distinctive brown color. This material is abrasive and will aggravate the looseness. If the looseness is enough to allow considerable movement of the inner or outer ring, the mounting surfaces (bores, outer diameters, faces) will wear and heat (see photo), causing noise and runout problems.

Discoloration and scoring is the result of outer ring slipping in the housing.

Consult Barden C-10 catalog or Barden Engineering for fit recommendations.

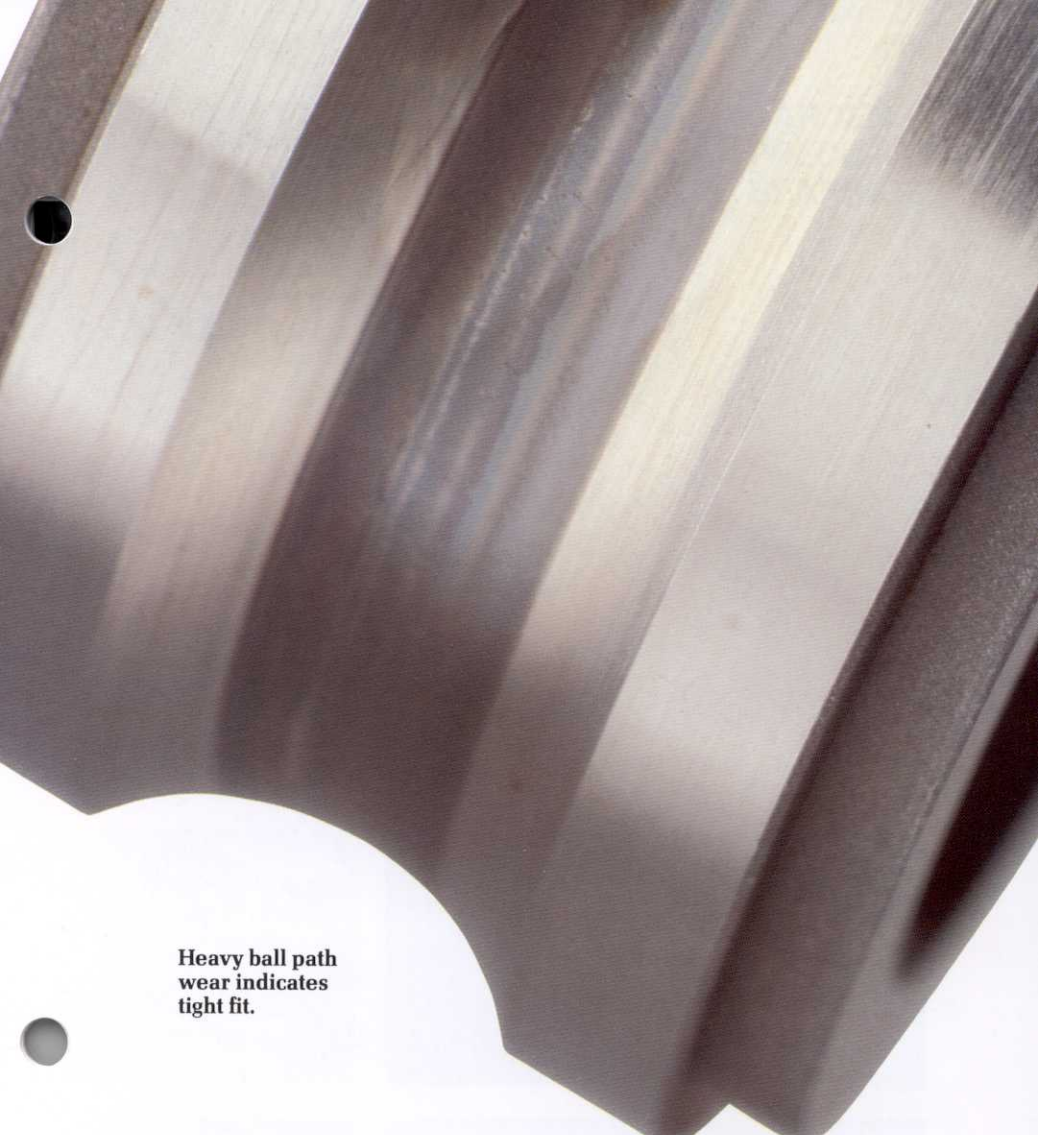
TIGHT FITS

Heavy ball path wear indicates tight fit.

Discolored, wide ball path at bottom of raceways.

A heavy ball wear path in the bottom of the raceway around the entire circumference of the inner ring and outer ring indicates a tight fit.

Where interference fits exceed the radial clearance at operating temperature, the balls will become excessively loaded. This will result in a rapid temperature rise accompanied by high torque. Continued operation can lead to rapid wear and fatigue.

Corrective action includes a decrease in total interference—better matching of bearings to shafts and housings—taking into consideration the differences in materials and operating temperatures. Increased radial clearance will also increase bearing life under the above conditions.
