SKF Reliability Systems

SKF condition monitoring technology averts plant failure at major UK paper mill

Iggesund Paperboard reports that its investment in SKF condition monitoring equipment has proven invaluable, by providing advance warning of the imminent failure of a critical large size bearing.

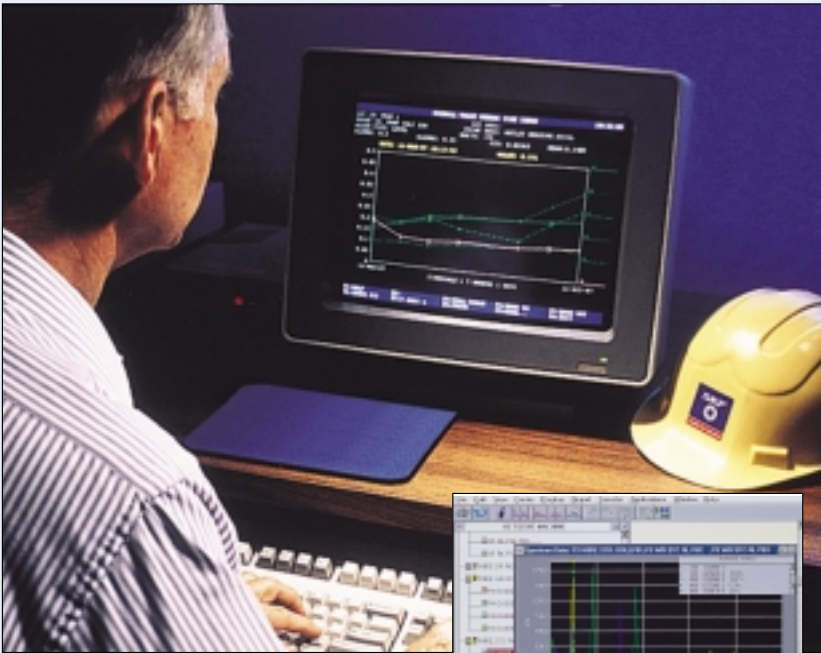
The offending bearing was then removed during a planned shutdown and it was found that the inner bearing raceway had two noticeable cracks.

Damage to rotating equipment can be the result of many factors, such as wear and surface distress, and cracks in bearings are generally seen as being secondary damage. SKF believe that the Iggesund condition monitoring team picked up such a secondary crack, which was caused by the stresses imposed by an earlier event.

After the fault was identified, the offending bearing was closely monitored on a daily basis, with the team observing a trend in which the vibration levels remained above the normal amplitude, as previously recorded, but varied with the speed of the machine.
